15

The Worst Structural Disaster in the United States

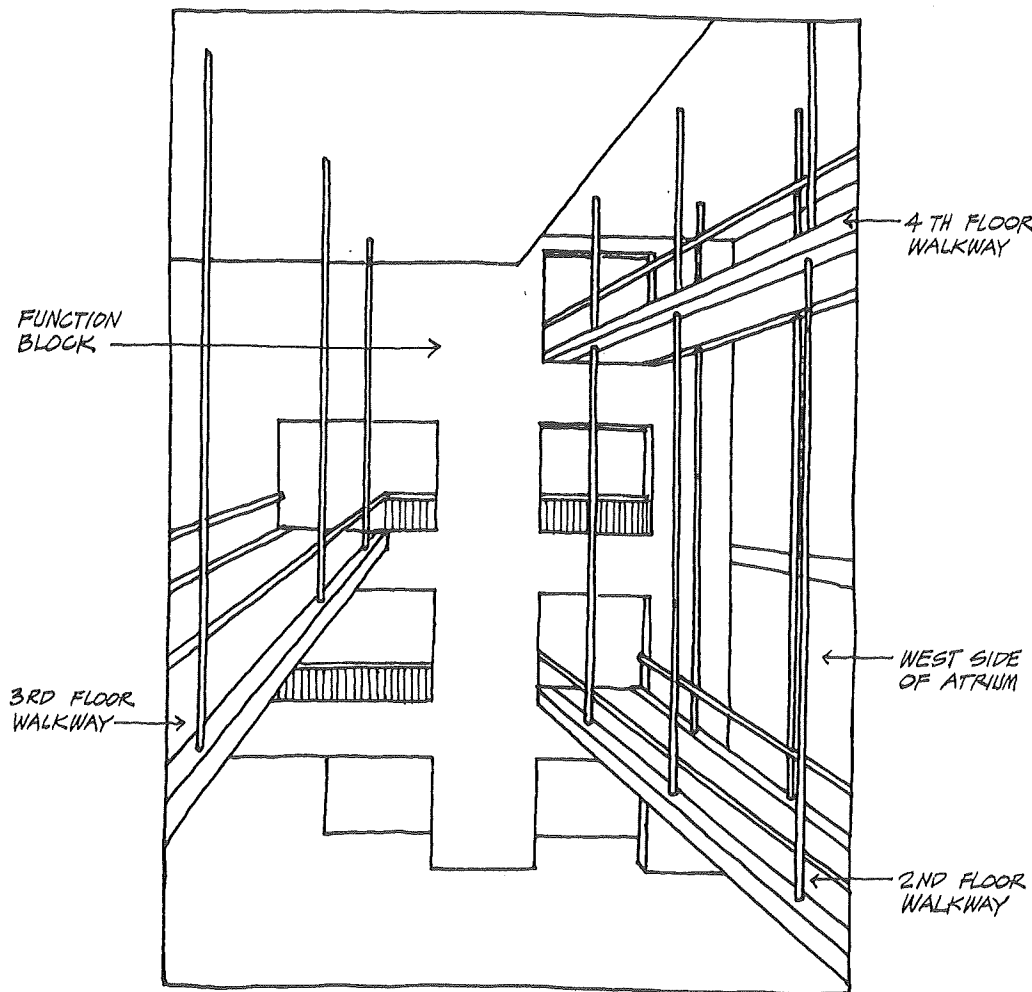
15.1 Atrium of Hyatt Regency Hotel, Kansas City, Missouri

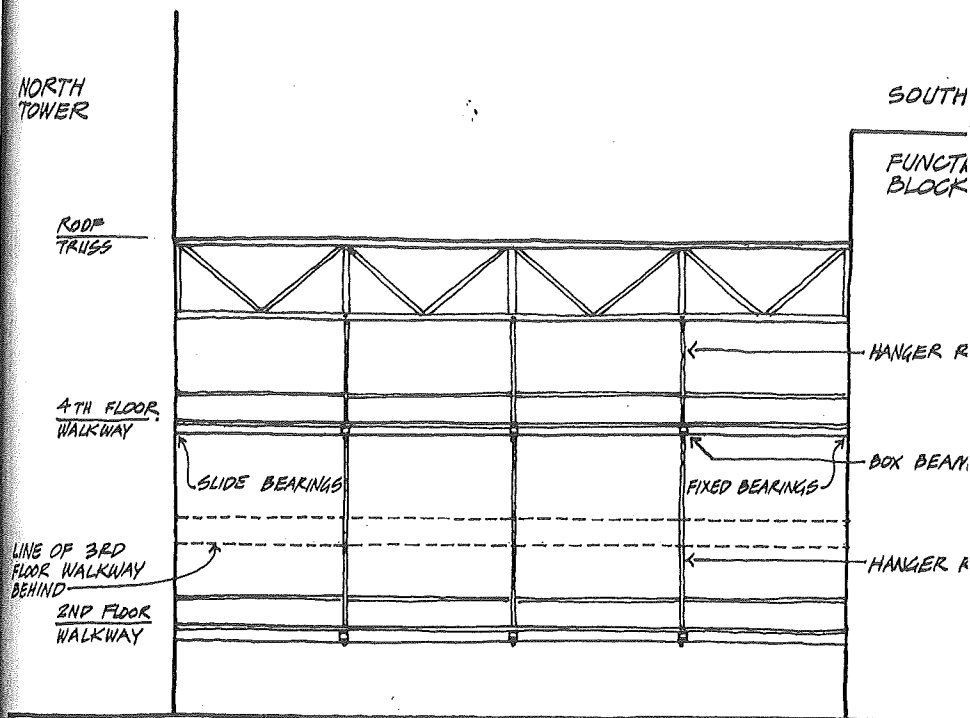
15.2 Elevation of West Side Atrium Showing Second- and Fourth-Floor Walkways

third-floor level near the east side of the atrium (Fig. 15.2). Restaurant service was available at a bar set *under* the two stacked walkways on the west side of the atrium. The main purpose of the walkways was to permit people to pass between the tower and the function block without crossing the often crowded atrium.

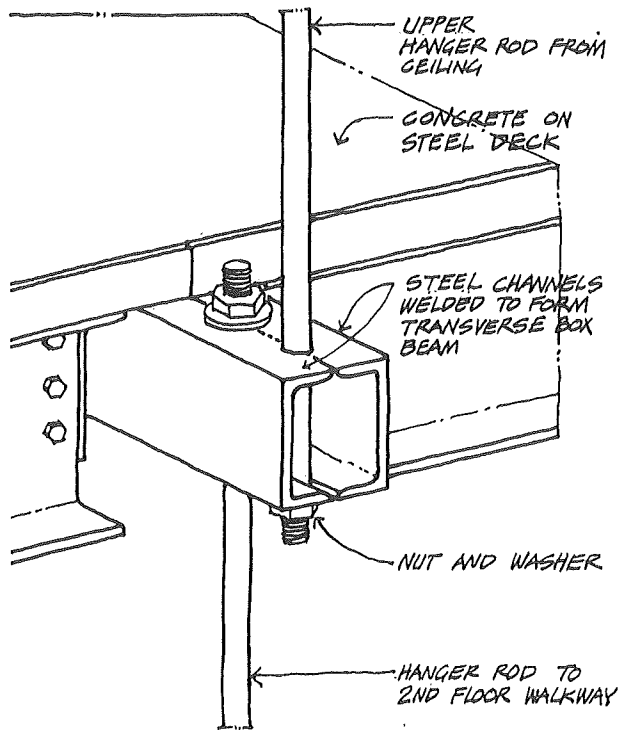
15.3 Box Beam Hanger Detail—as Built

In the *shop drawings* (the final drawings submitted by the contractor to the design engineers and the architects) each end of the fourth-floor box beams had *two* holes through both flanges, one at 2 in. (50 mm) from the end and the other at 6 in. (150 mm) from the end (Fig. 15.3). Two *upper* hangers, ending at the fourth-floor level and consisting of 1¼ in. (32 mm) rods, went through the *outer* hole in each box beam of the fourth floor and supported the *fourth-floor walkway only* by means of nuts and washers at their *lower* end—i.e., *below* the box beams of the fourth-floor walkway. Two separate *lower* rod hangers, starting at the fourth-floor level, went through the *inner* hole of each fourth-floor box beam, supported by a nut and washer at their *upper* ends—i.e., *above* the fourth-floor box beam—and supported at their lower ends the second-floor walkway. This design was a change suggested by the contractor in the *shop drawings* and stamped “Approved” by the architects and “Reviewed” by the structural engineers. (Design engineers are advised by their attorneys never to stamp the contractor's shop drawings “Approved”.) In the final contractor's design the loads of *both* walkways was transmitted to the roof trusses by the shorter upper rods, which passed through *only the fourth-floor box beams* and supported the second-floor walkway by two additional shorter rods hanging from the fourth-floor box beams. Thus in this design the fourth-floor transverse box beams supported the loads of *two* walkways, rather than the *one* of the original design.

The six upper hanger rods, carrying the load of the walkways and thus supporting 24,000 lb. (107 kN) each, pulled up on the thin lower flanges of the fourth-floor box beams through a single nut and bolt connection. Under this load (*twice* the design load), the bolt first bent the lower flange of the box beams, then broke through the lower hole in it, pulled out of the hole in the upper flange, and became disconnected from the box beam (Fig. 15.5). This first happened at the midspan upper hanger rod; the remaining upper rods, incapable of taking over the load unsupported by the failed rod, pulled out of their holes, and both walkways fell down. The walkway system not only was underdesigned but also lacked redundancy (see p. 55), a most prudent reserve of strength

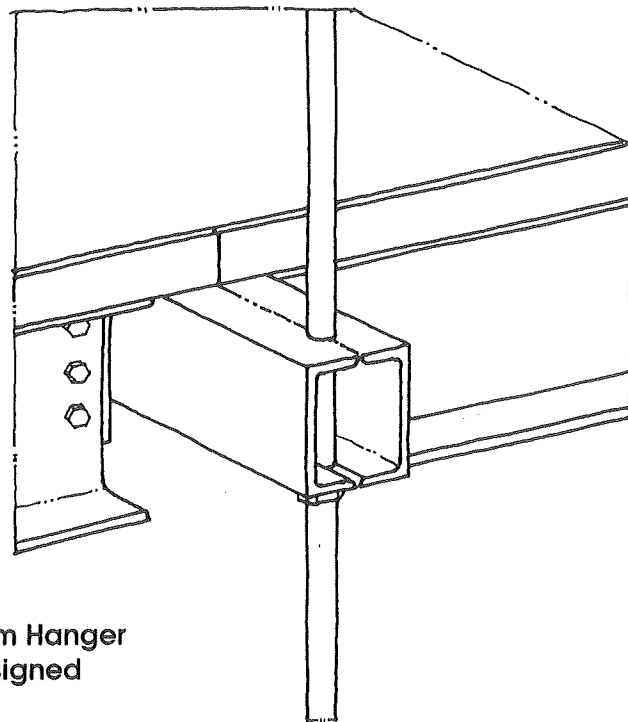
Intermediate supports of the walkways at each end of the 30 ft. (9 m) beams consisted of transverse *box beams*, fabricated by butt welding along their entire length two 8 in. (200 mm) deep channels (Fig. 15.3). In the *original working drawings* (the last engineering drawings submitted to the contractor and the architects by the design engineers) each box beam had *single* holes at both ends of the flanges (Fig. 15.4), through each of which was threaded a single 1¼ in. (32 mm) steel rod that served as hanger for *both* the second-

15.4 Box Beam Hanger Detail—as Designed

and fourth-floor walkways. In this design the load of *both* walkways was supported every thirty feet by means of nuts screwed into a *single* rod on each side of the walkways at the level of the second-floor *and* the fourth-floor box beams. Thus the single rods hung from the steel trusses of the atrium's roof supported the weights of *both* walkways, but the box beams of *each* walkway supported only the loads on *that single* walkway.

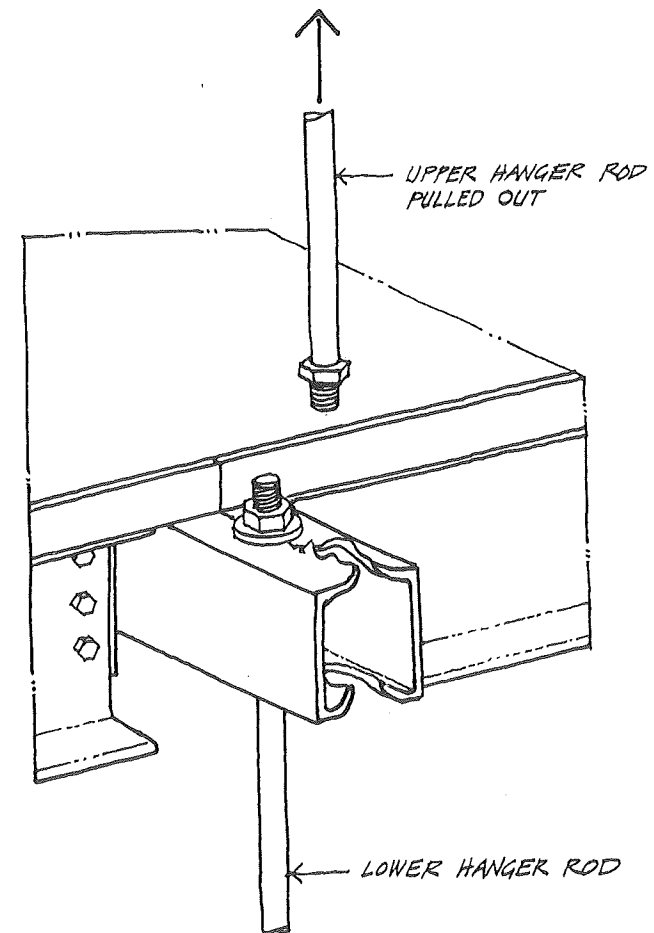
Pfrang and Marshall realized immediately that the weak elements in the chain of structural elements were the box beams of the fourth floor. But since the stress analysis of the complex beams could not be accurately obtained by theoretical calculations, they tested in the laboratory both brand-new duplicates of the box beams and some of the undamaged actual box beams. They also computed *and* tested the ultimate strength of the hanger rods. They could thus *prove* the real cause of the walkway collapse.

15.5 Pulled-Out Rod at Fourth-Floor Box Beam
